July 2012 Test Report

Report No: EF2012-G

Executive Summary

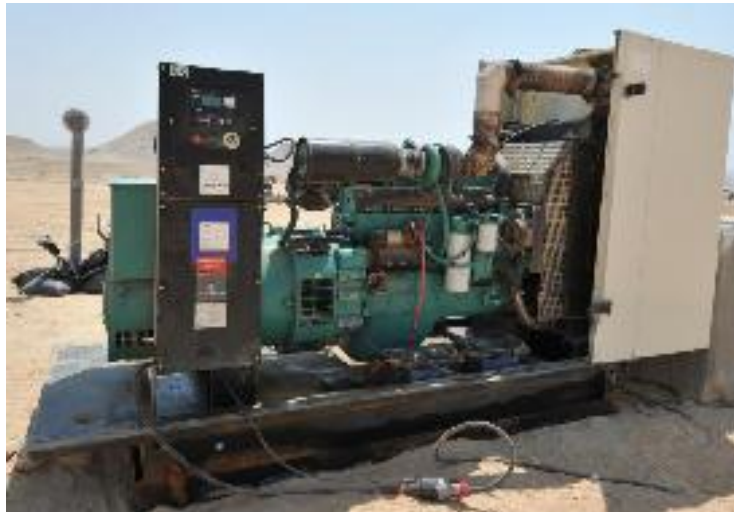
Figure 4 Generator Target

A typical industrial generator was purchased and the outer shell was removed which exposed all the internal components to the full effects of the blast as shown in Figure 4. The goal of this test is to see not only how equipment performs under blast conditions, but also to determine what type of damage occurs and possible retrofit strategies.

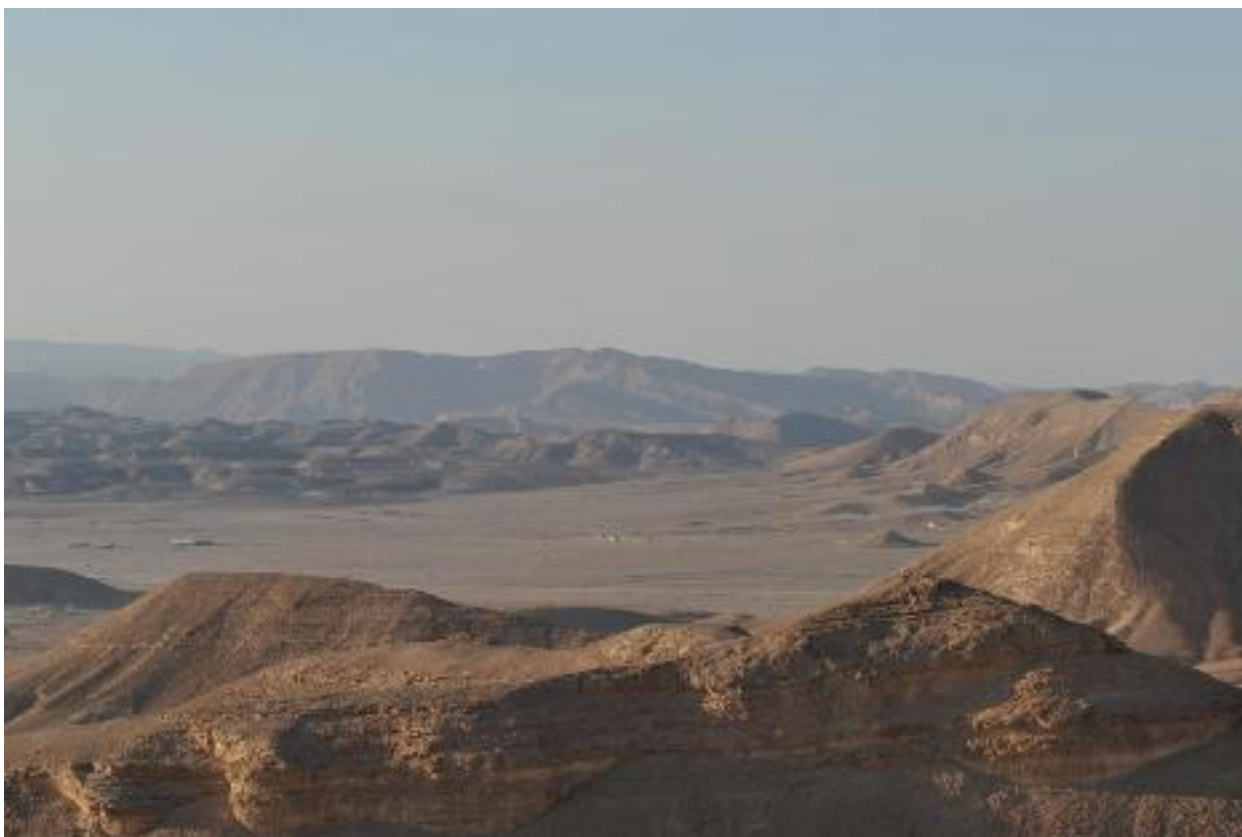
The test site was approximately 1000m long by 750m wide and bounded by hills to the North, South and East as shown in Figure 5. The terrain was rocky, flat desert pavement.

Figure 5 Test Site

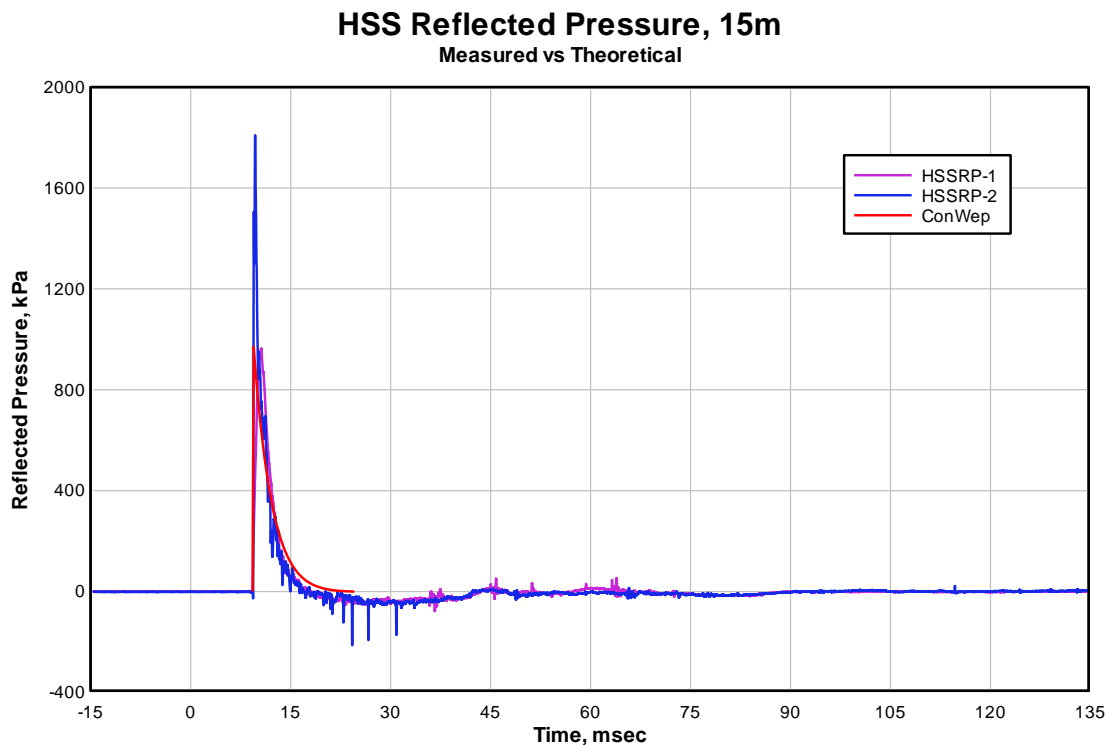
Figure 16 Test 2: HSS Target Reflected pressure-time History

It can be seen that the measured peak pressures matched predictions well. The only pressure gauge that did not work during the test was the free-field pressure gauge located at 15m standoff in the second test. Although the peak pressures observed matched the predictions quite nicely, the reflected impulses were lower than predicted due to clearing effects.

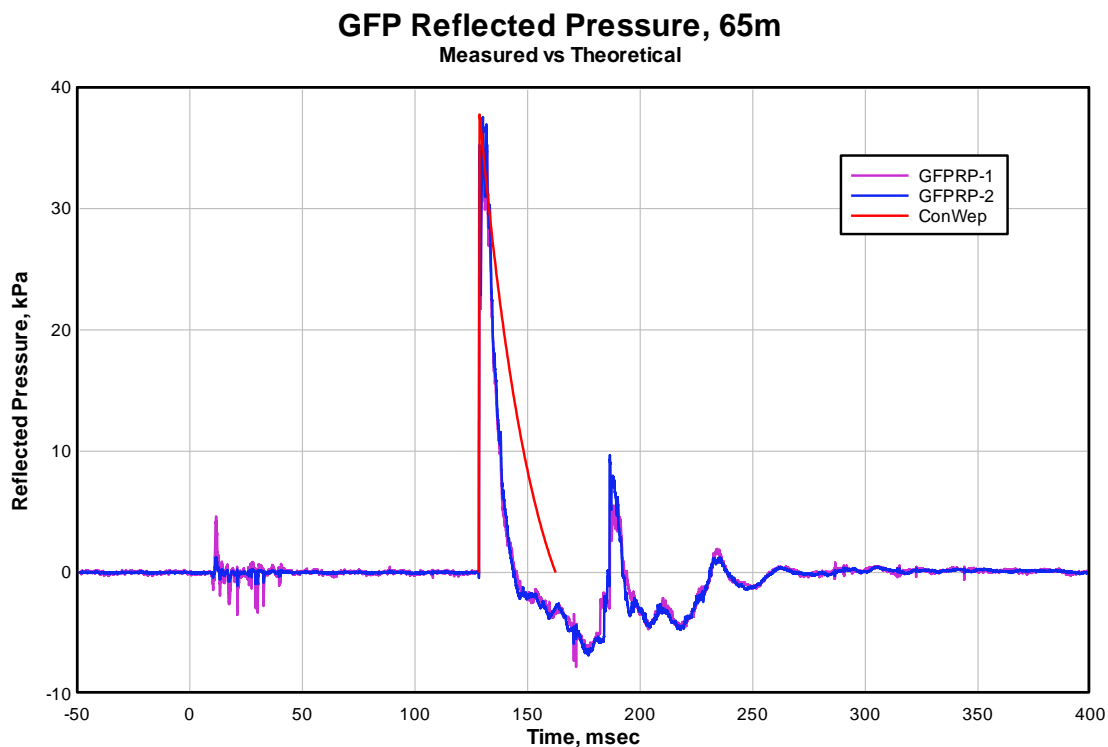
Figure 18 Test 2: GFPM Target Reflected Pressure-time History

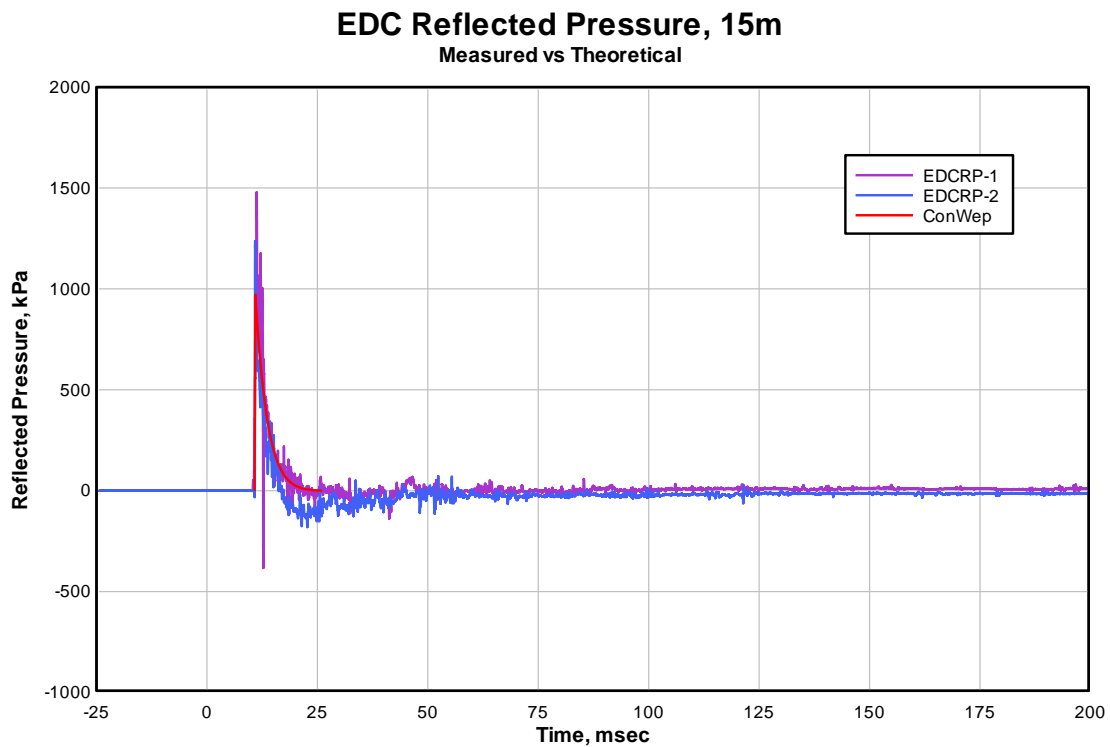
Figure 20 Test 2: EDC Target Reflected Pressure-time History

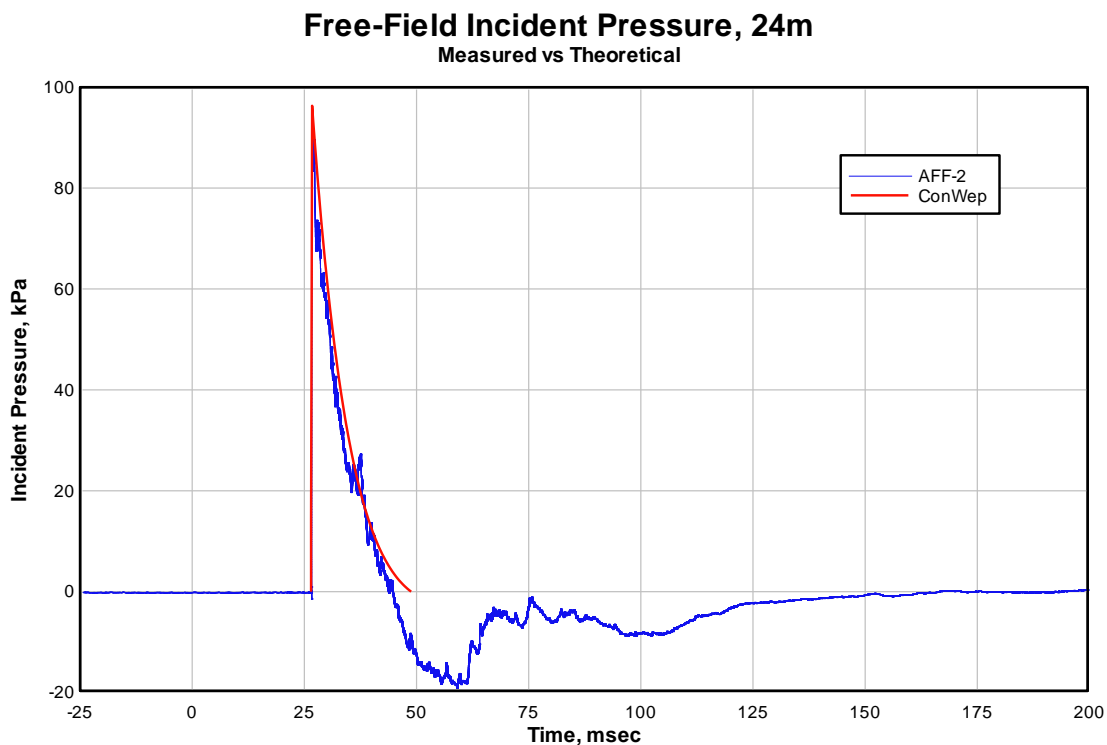
Figure 23 Test 2: Free-field Pressure Time History at 24m Standoff

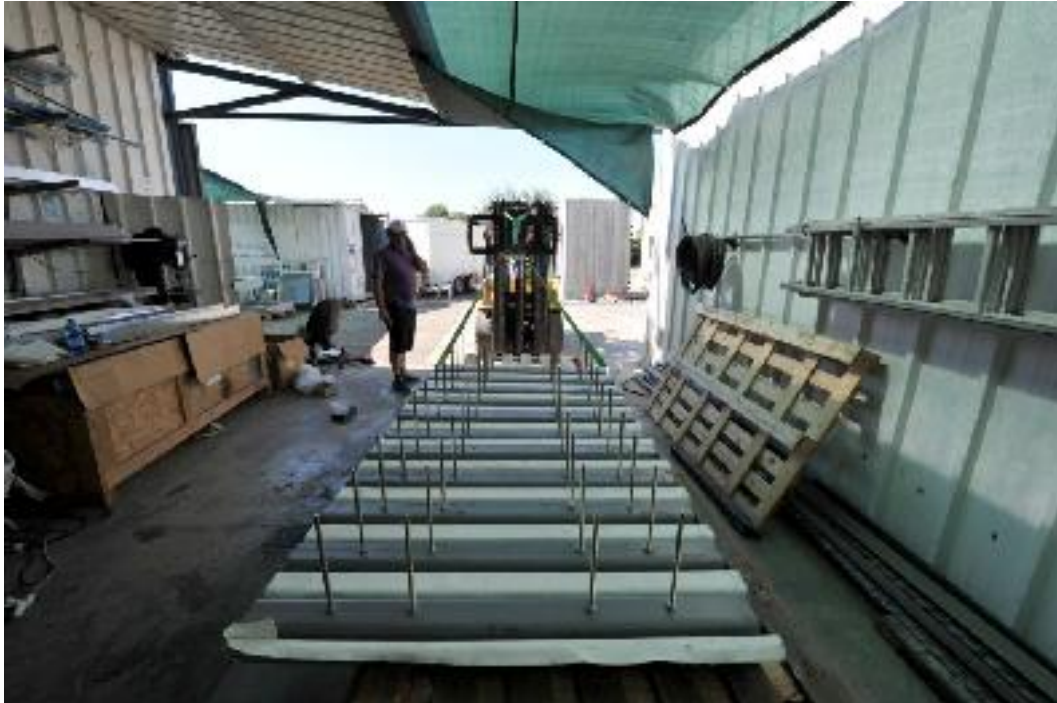
Figure 24 Assembly of the Cladding for HSS Target

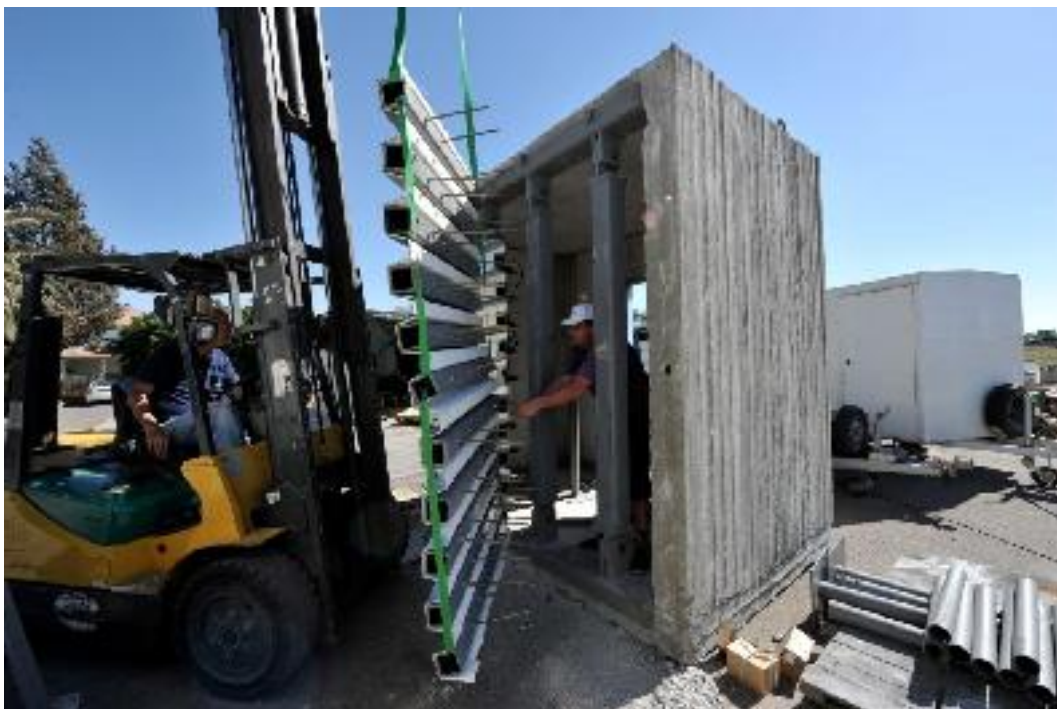
Figure 25 Installation of Cladding on HSS Target

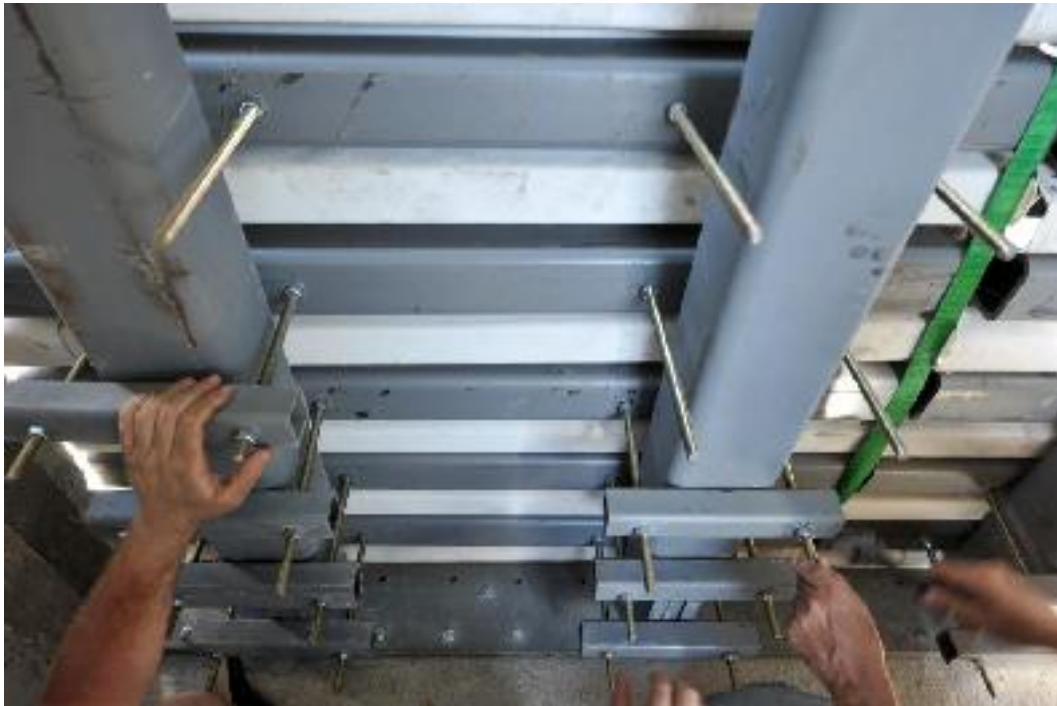
Figure 26 Tightening of Cladding Supports for HSS Target

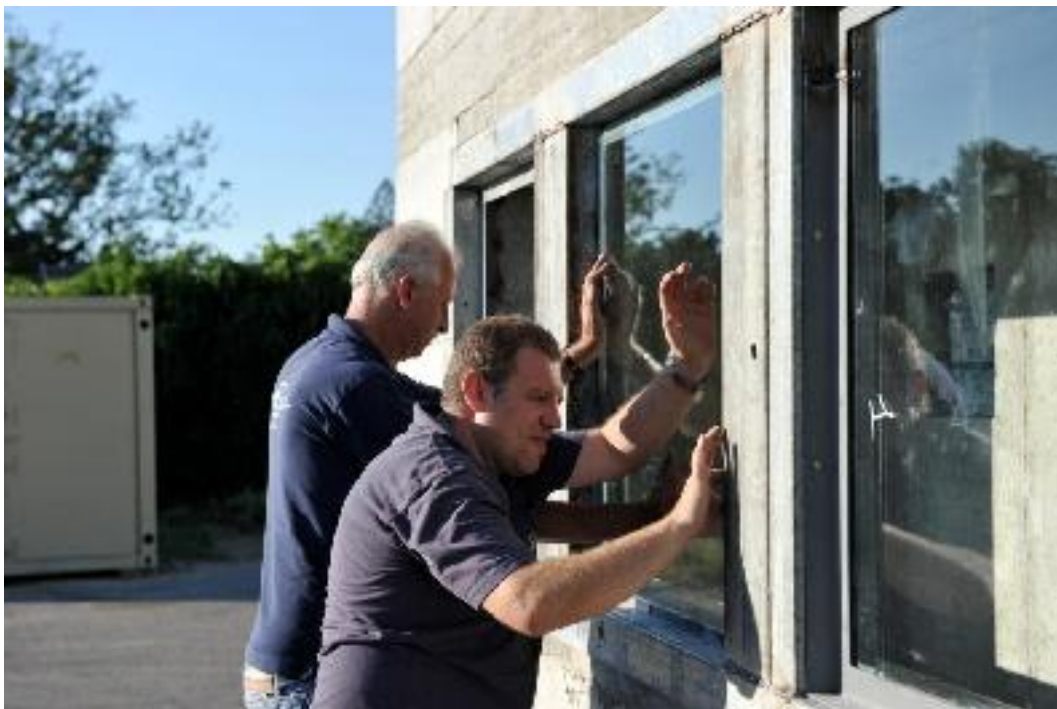
Figure 28 Glass Panes and Supports Being Installed into GFPM Target

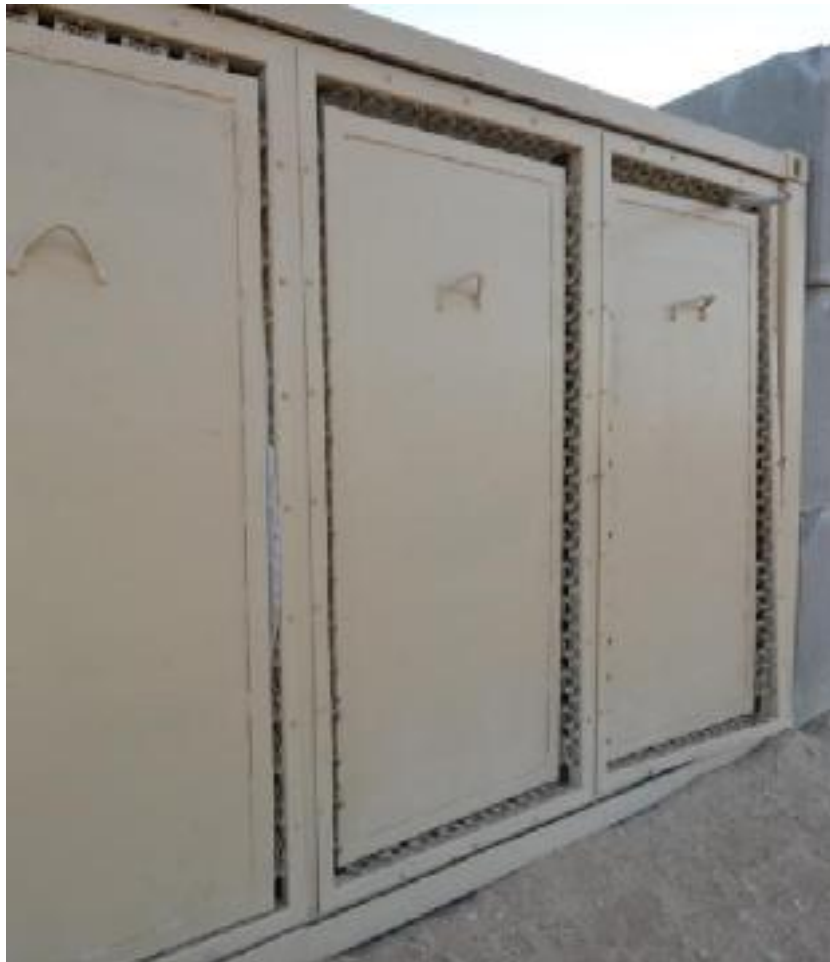
Figure 34 EDC Target Following Test 1

During the first test, the EDC target behaved as expected and the movement of the panels agreed with predictions. The middle, heavier panel had noticeably less deflection than the lighter outside panels. For the second test, the entire target was rotated so that the panels facing the outside of the arena during the first test were facing the charge. Following the second test, large movements were observed in all panels as expected. Some connections of the EDC's to the test structure failed, as did the steel frame of the target where holes drilled for the reflected pressure gauges had weakened the structure. The second test was intended to test the system to its limits, which explains the failure of some components of the target.

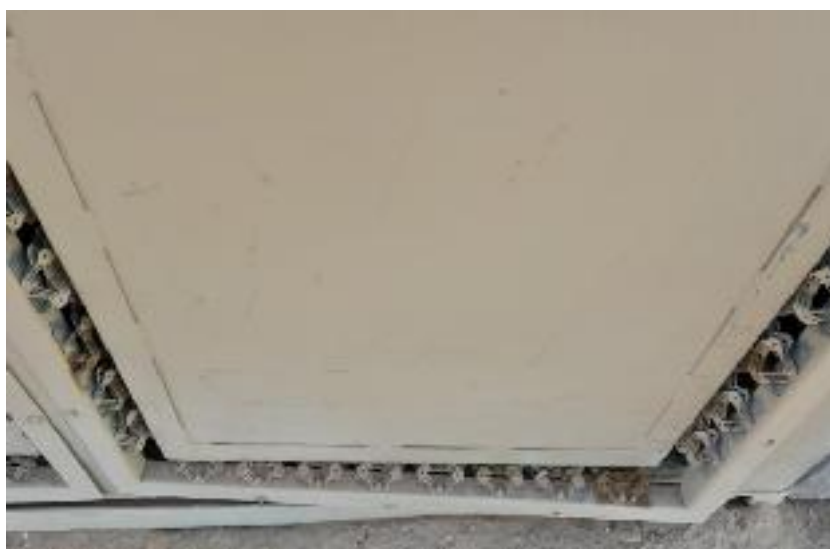
Figure 35 EDC Target Corner Detail Following Test 1

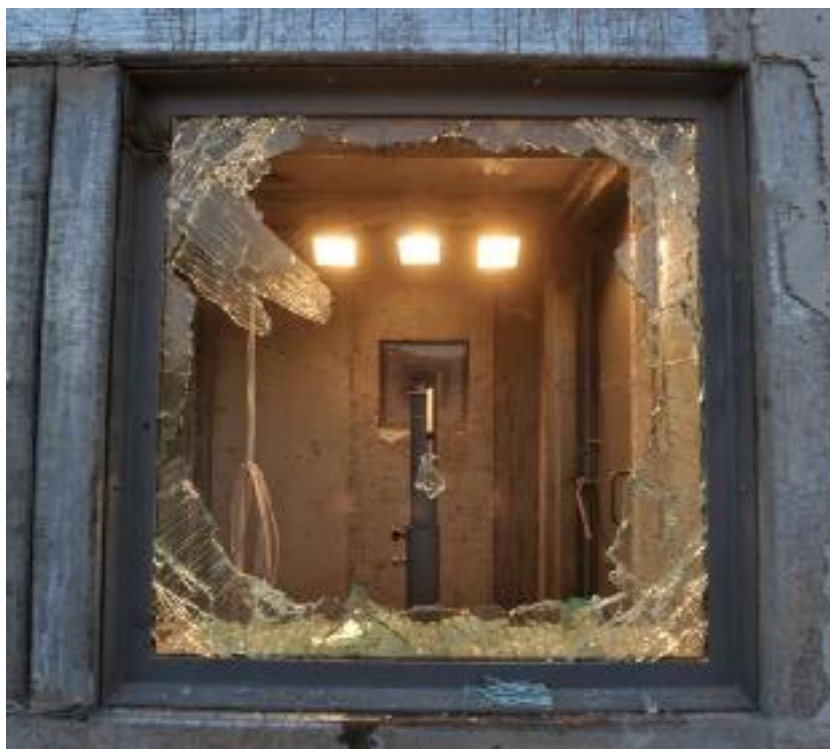
Figure 37 GFPM Target Broken Window Following Test 1

In the first test, the GFPM target only had one window break, which is why it was moved to a 65m standoff for the second test from 75m in the first test. Despite the closer distance, no windows broke in the second test. In the first test, the high-speed cameras did not trigger since they overheated due to the temperature. For the second test, a cooling system was deployed for the cameras to address the overheating issue. In the second test, all of the cameras triggered correctly.

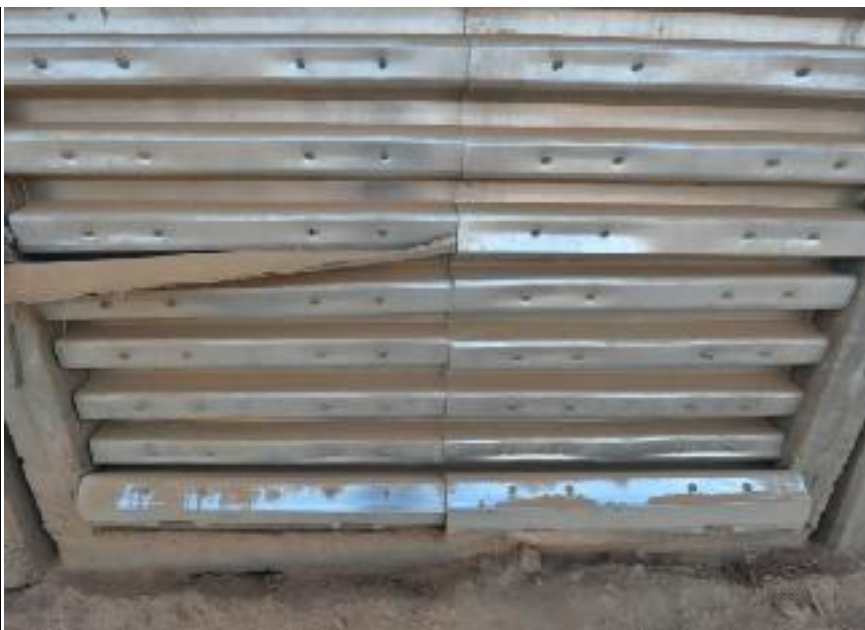
Figure 39 HSS Target Following Test 1, Support Rotation

The bottom connection of the HSS beams rolled inwards pulling out some of the anchor bolts in the first test. The top and bottom connections were repaired and strengthened over the course of one day to be ready for the second test. This allowed for a more successful second test since the supports did not move during the positive phase and the HSS members received the full blast load and deformed as planned.

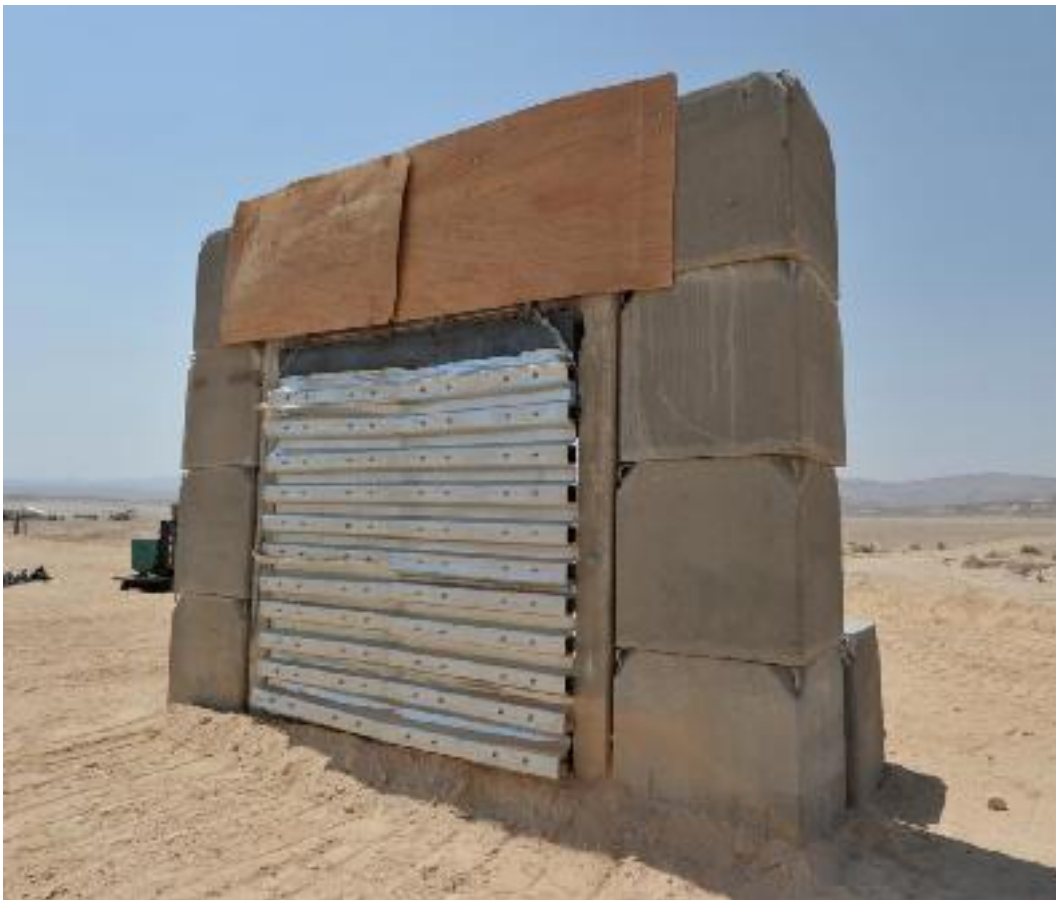
Figure 43 HSS Target Repaired Prior to Second Test

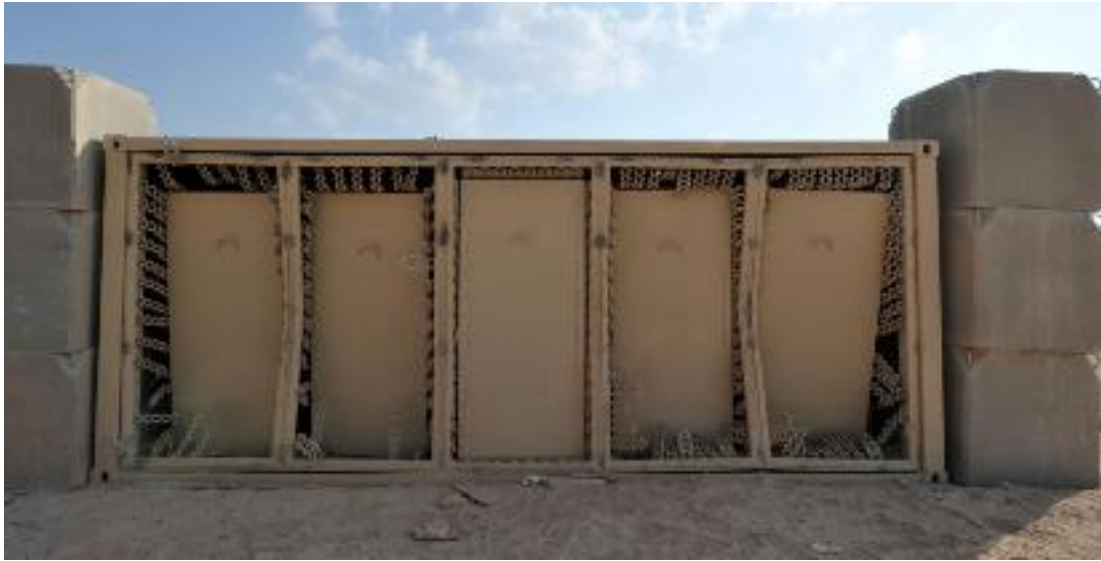
Figure 44 EDC Target Following Test 2

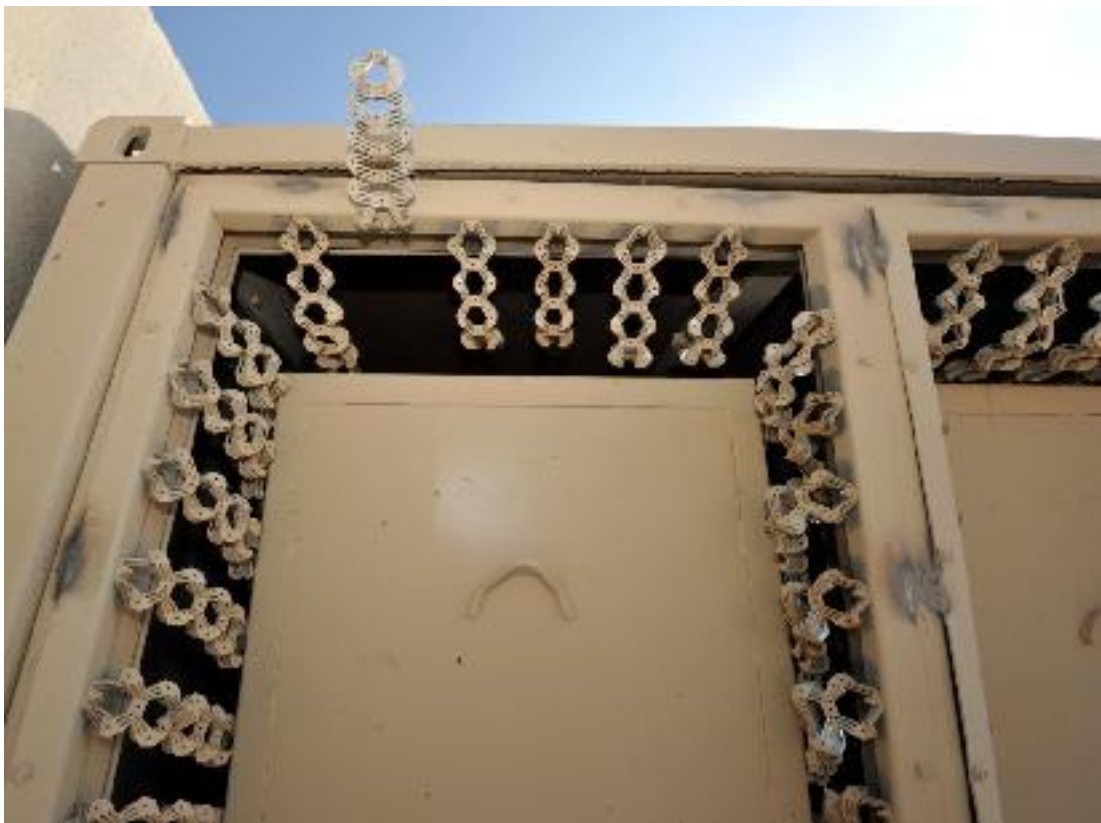
Figure 45 EDC Target Panel Following Test 2

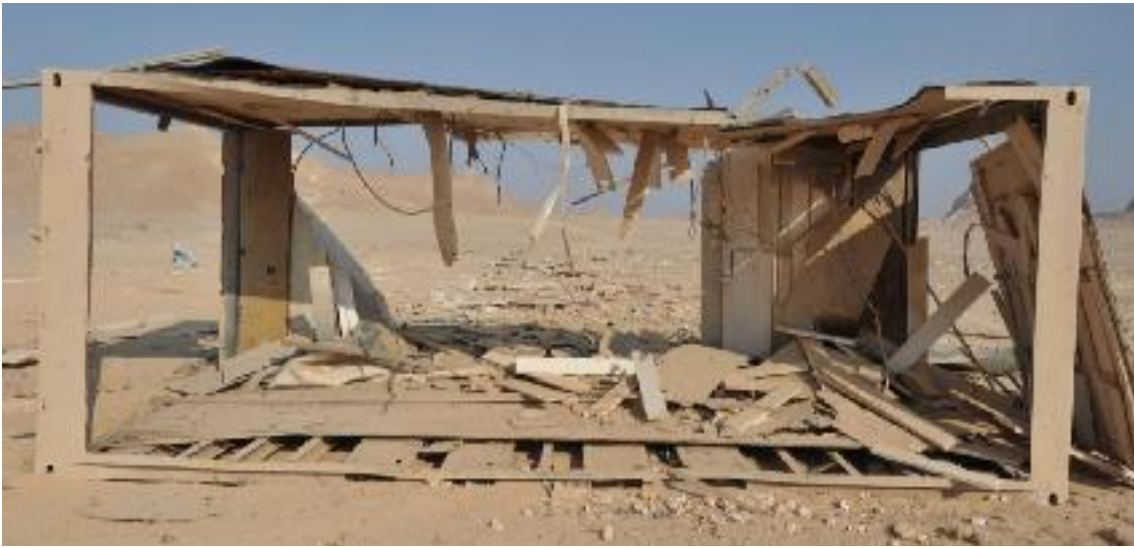
Figure 46 Modified Steel Framed Sea Container Office Following Test 2

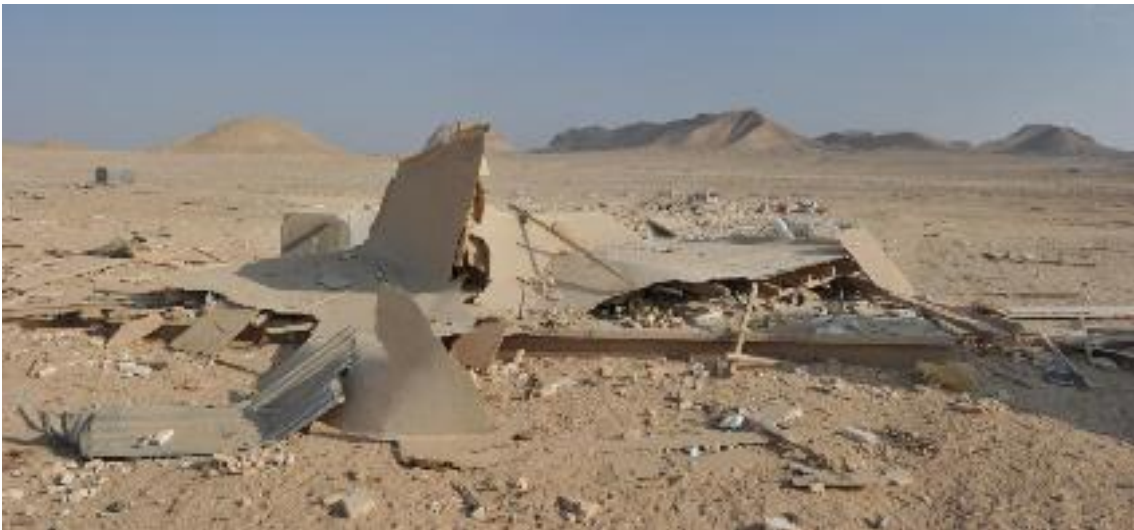
Figure 47 Site Office Following Test 2

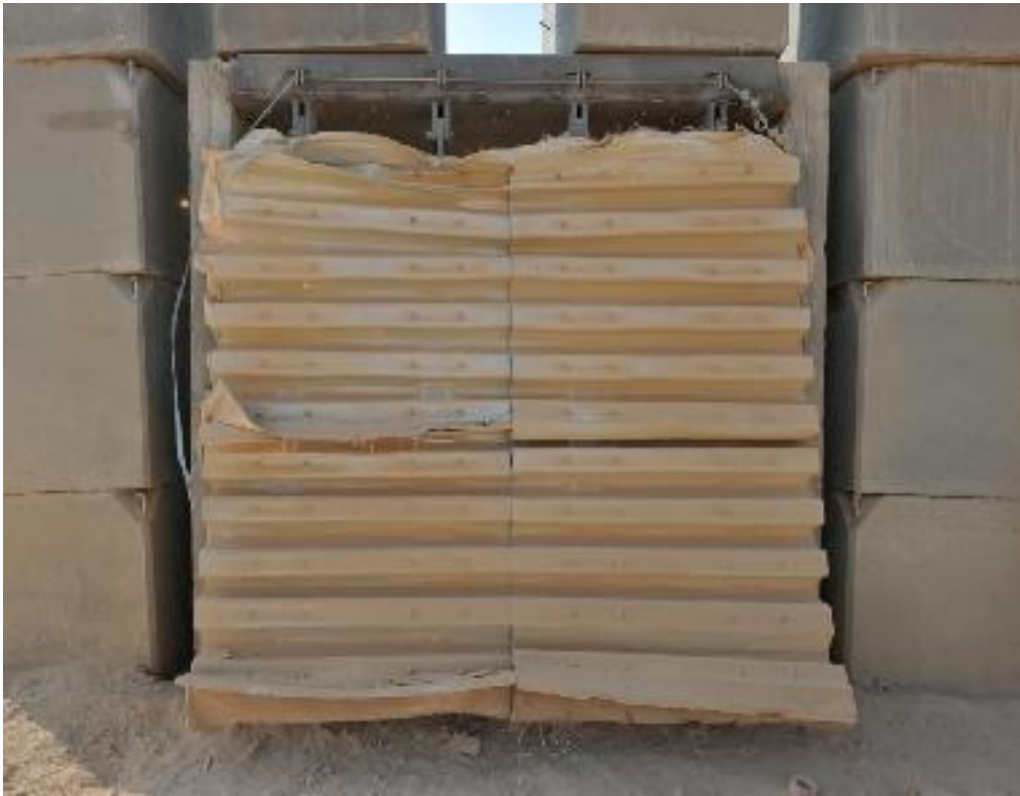
Figure 49 HSS Target Following Test 2

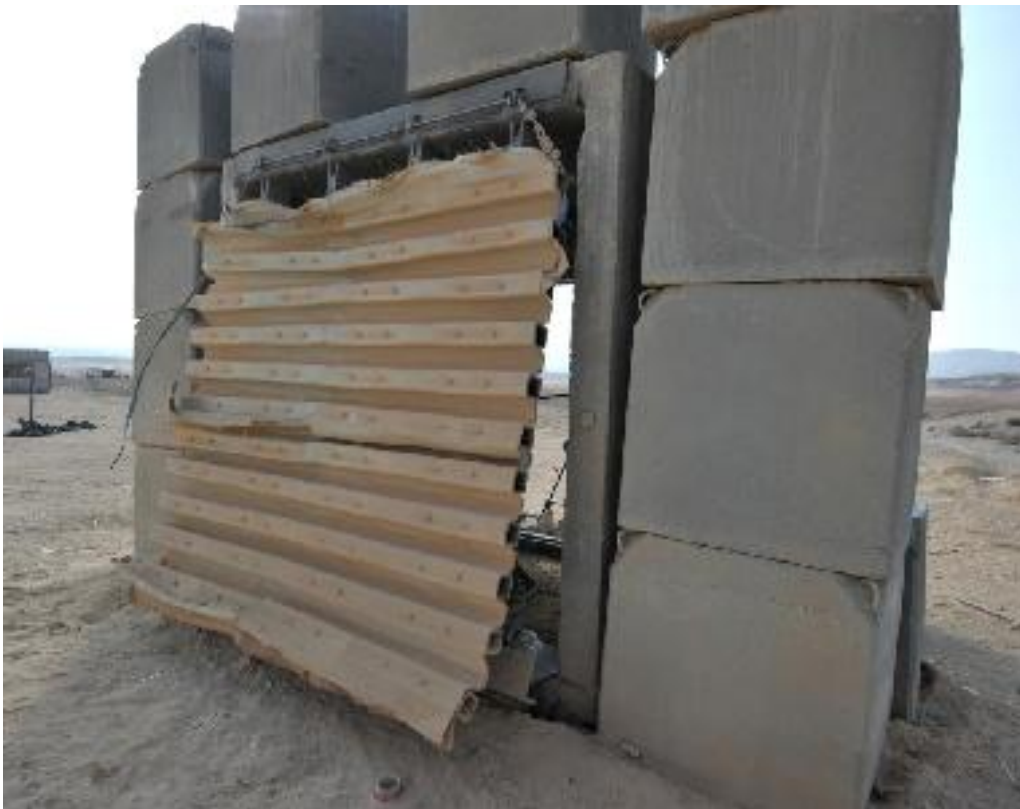
Figure 50 HSS Target Following test 2
