SANDFORD FLEMING FORUM

Resilience: Emerging Thinking and Practice

Seismic Resiliency

Dr. Michael Gray

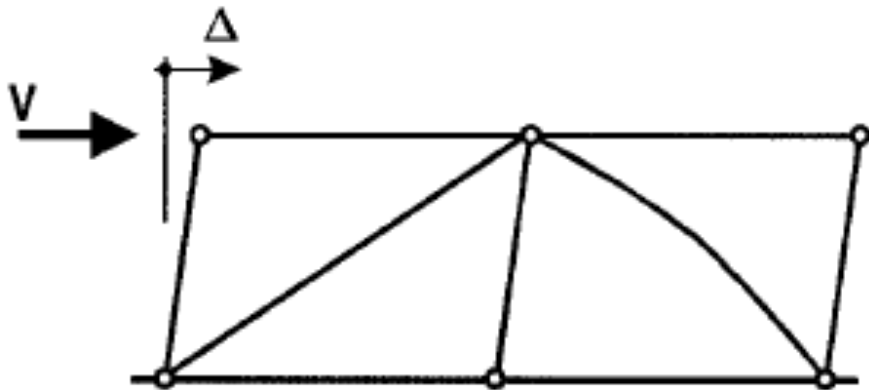
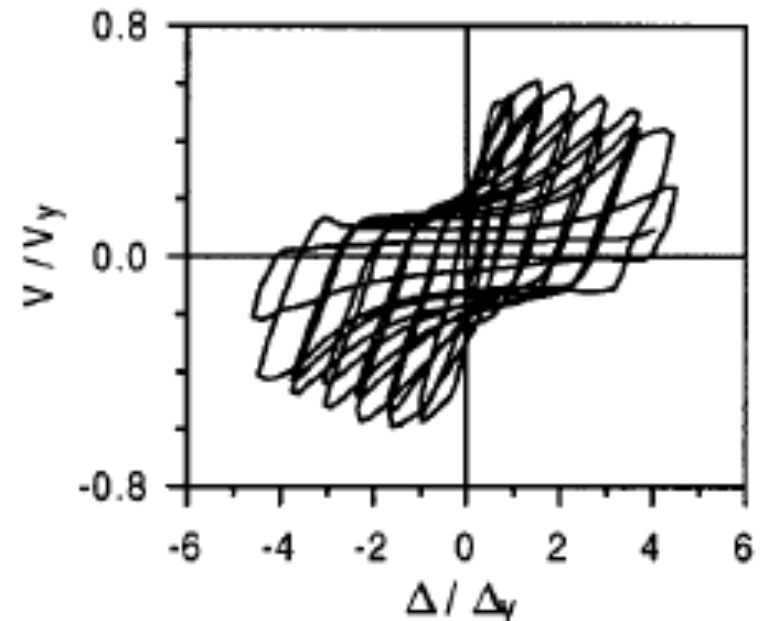
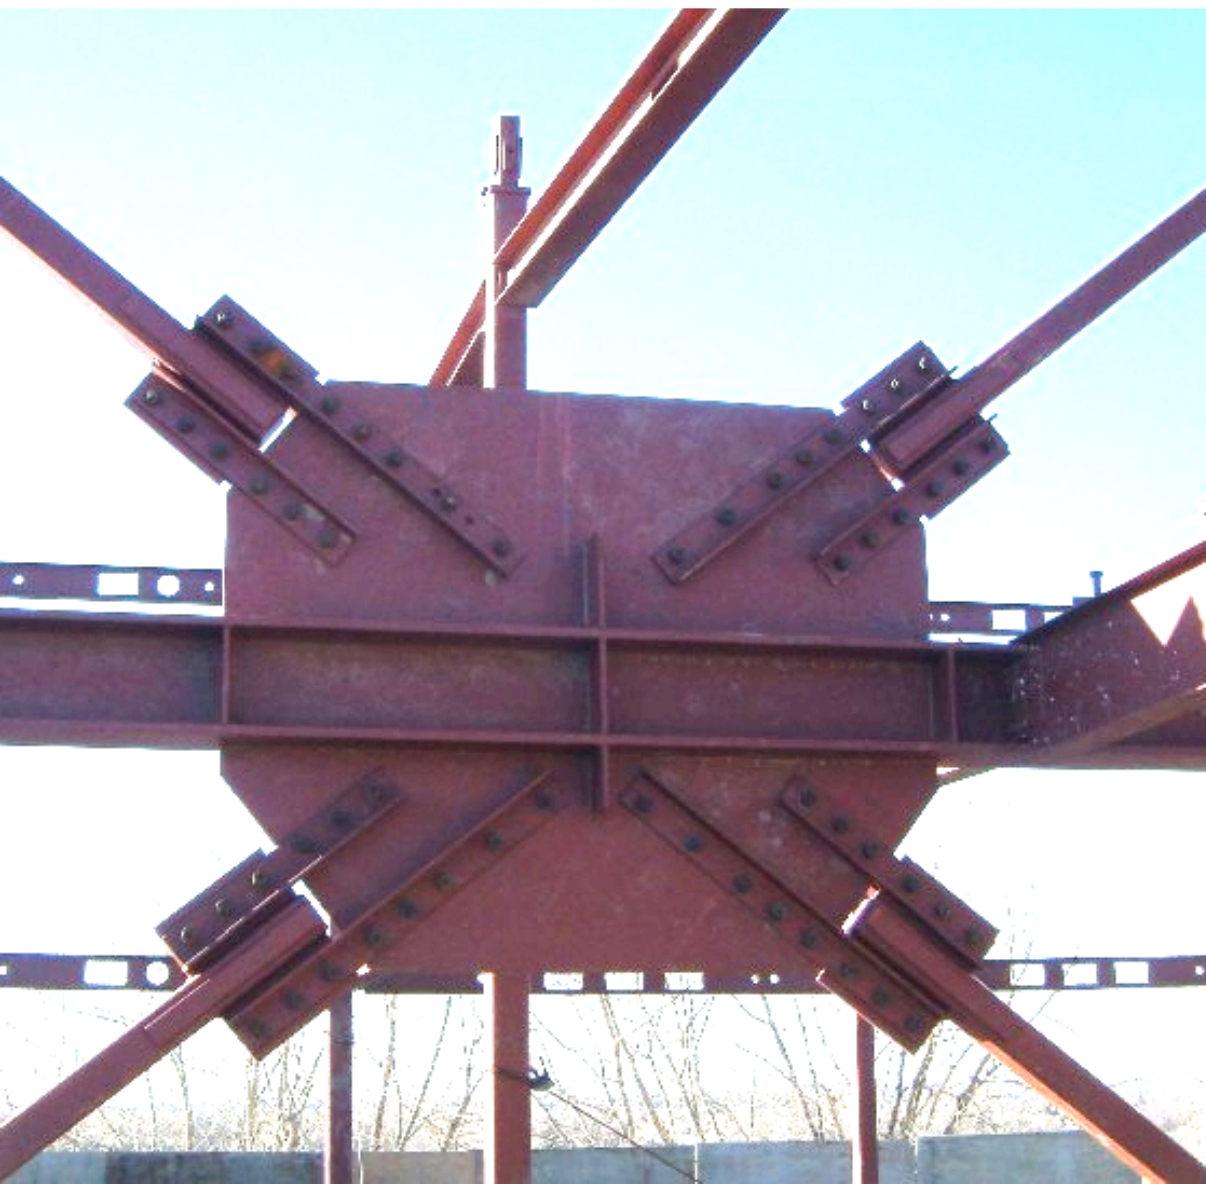
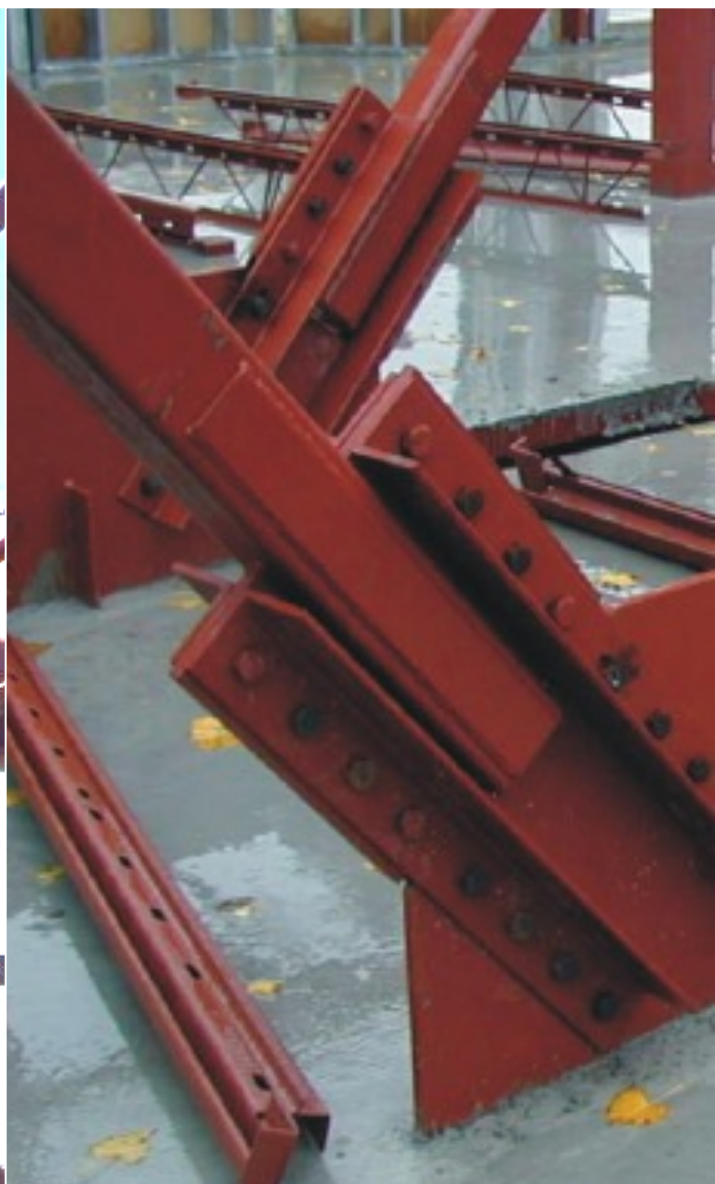
Earthquake Response of Braced Frames

As a frame deforms beyond its elastic range, its brace members are intended to **yield in tension** and **buckle in compression**

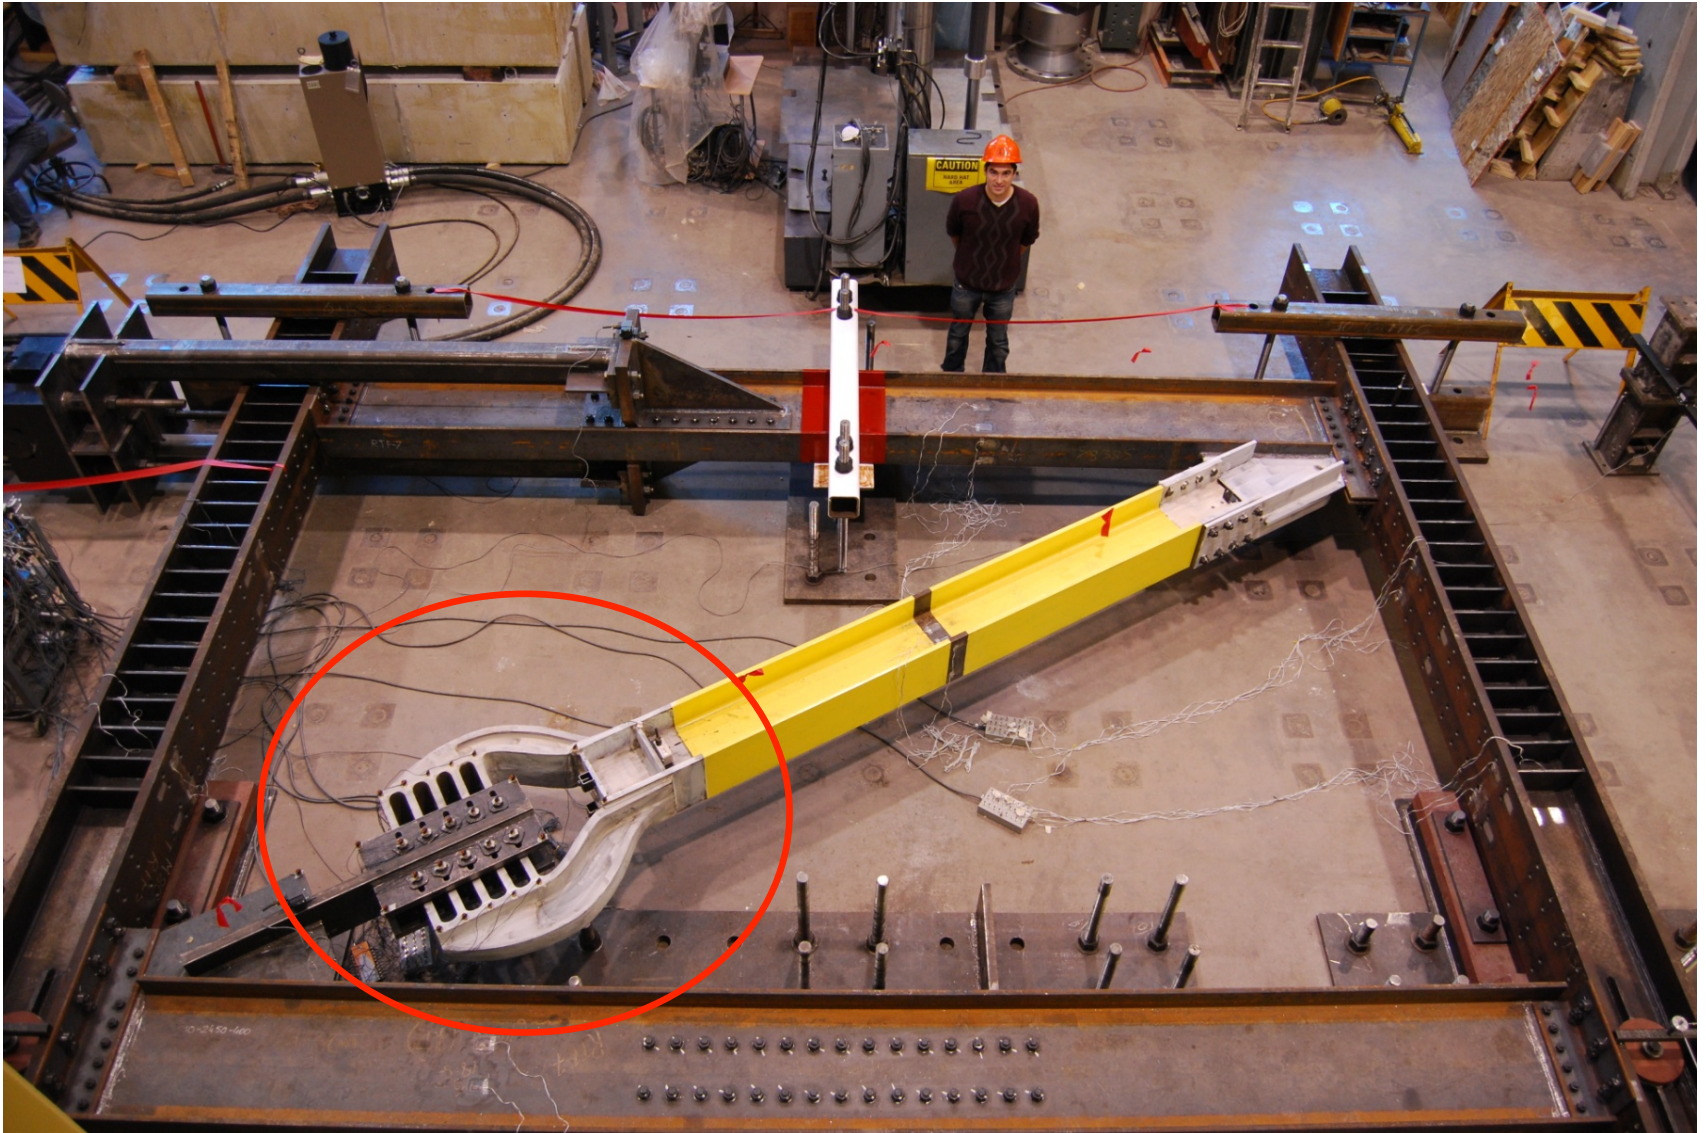
Yielding Connector

Two Cast Arms Welded to the End of the Brace Member

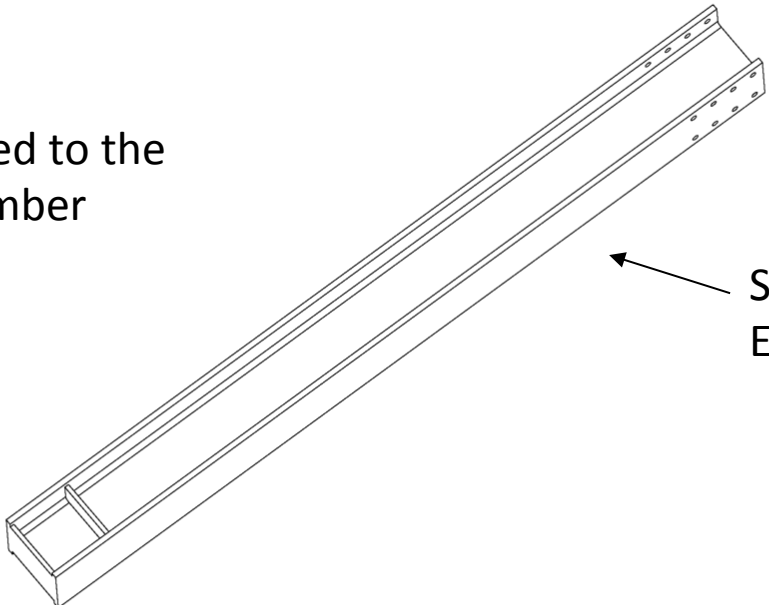
Standard Fabricated Elements

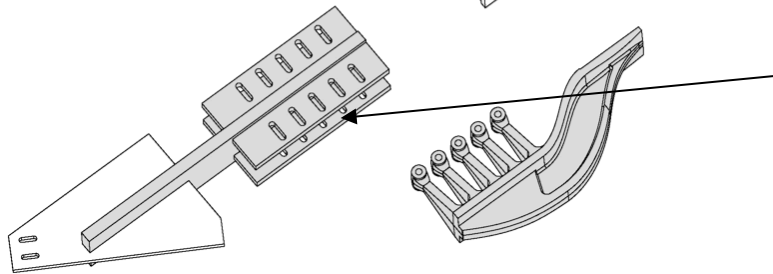
Machined Splice Plate Assembly Welded to Corner Gusset

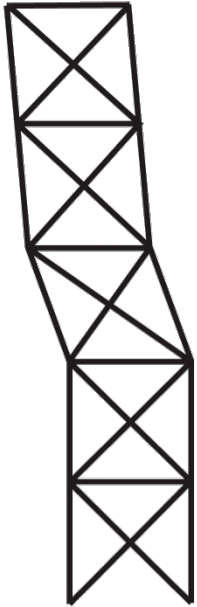
Traditional
braced frame
with low
post-yield
stiffness

Effect of Post-Yield Stiffness

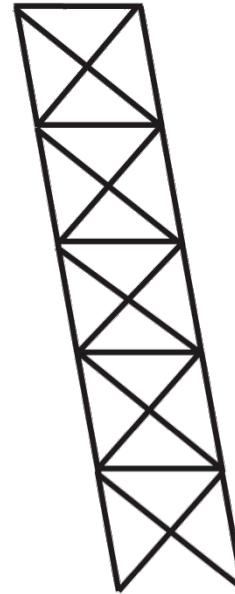
Scorpion
braced frame
with
increasing
post-yield
stiffness

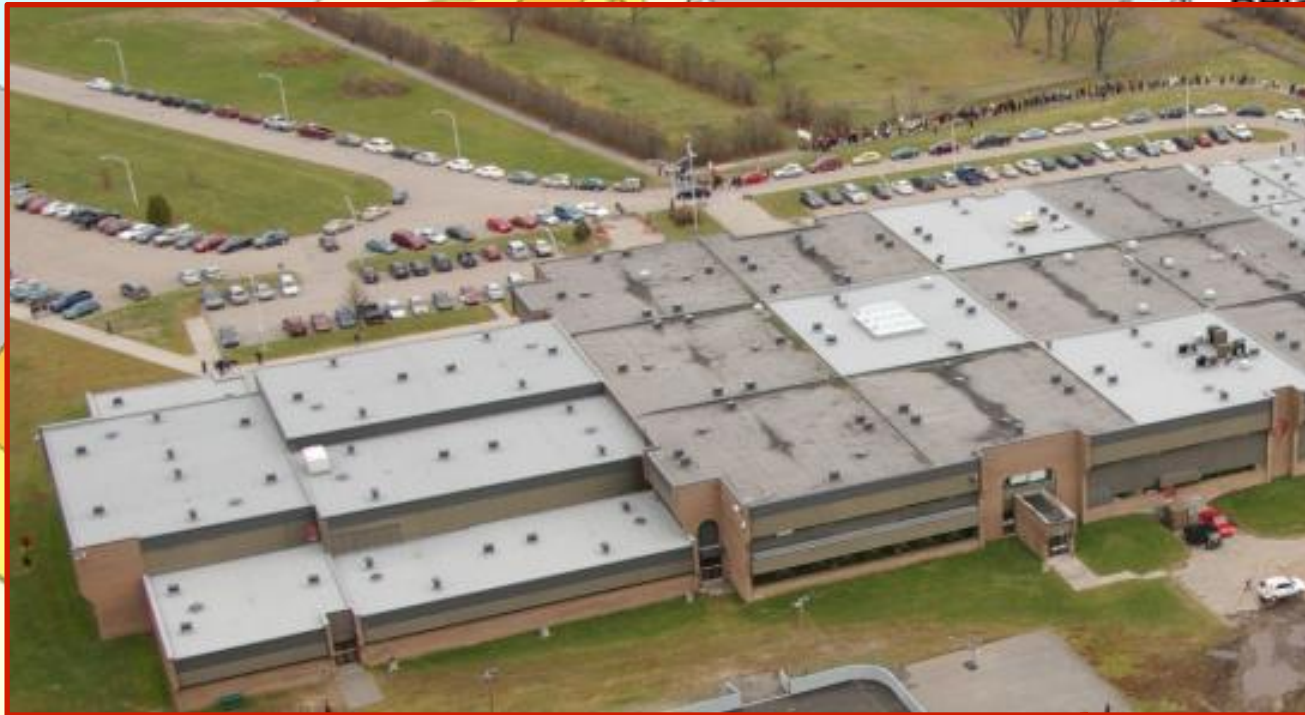
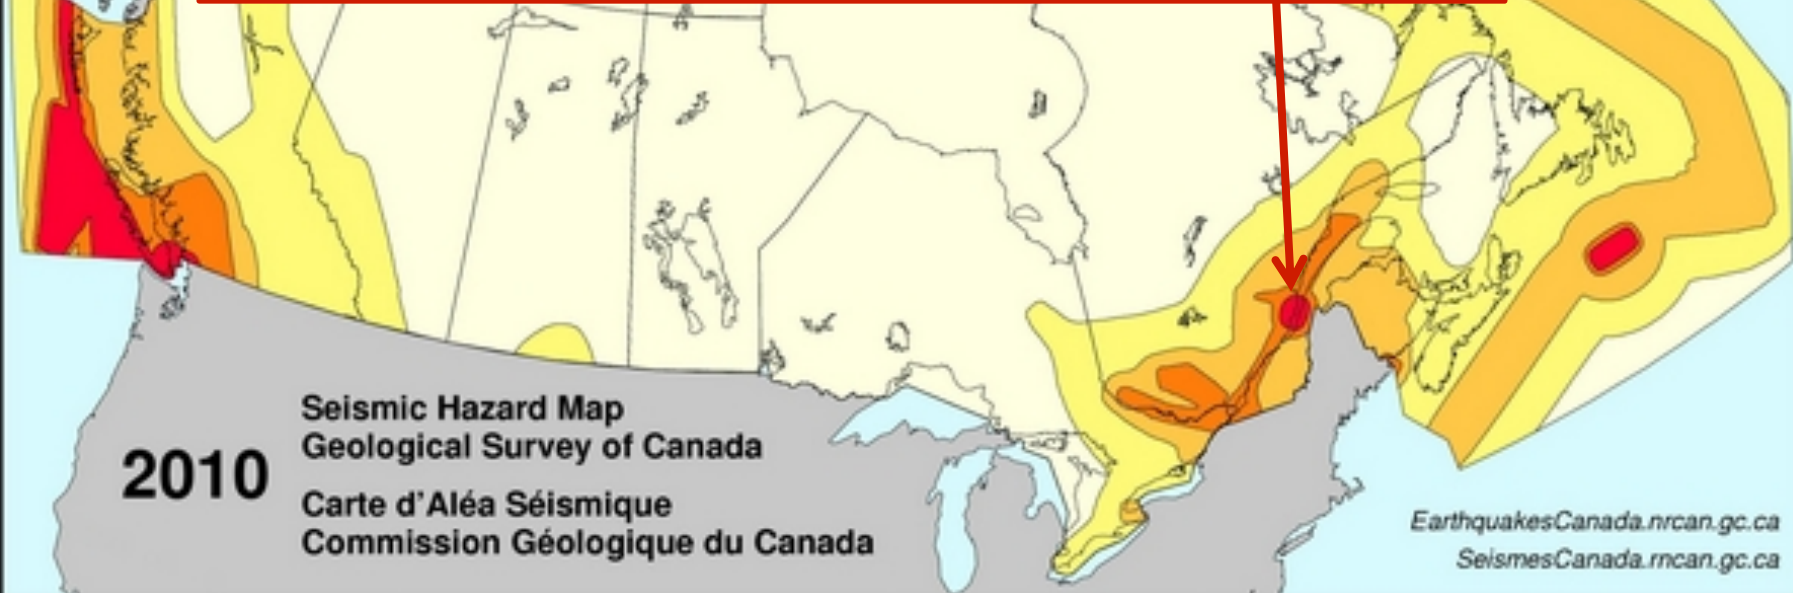
**Aléa
Relatif** **Relative
Hazard**

2010

**Seismic Hazard Map
Geological Survey of Canada
Carte d'Aléa Séismique
Commission Géologique du Canada**

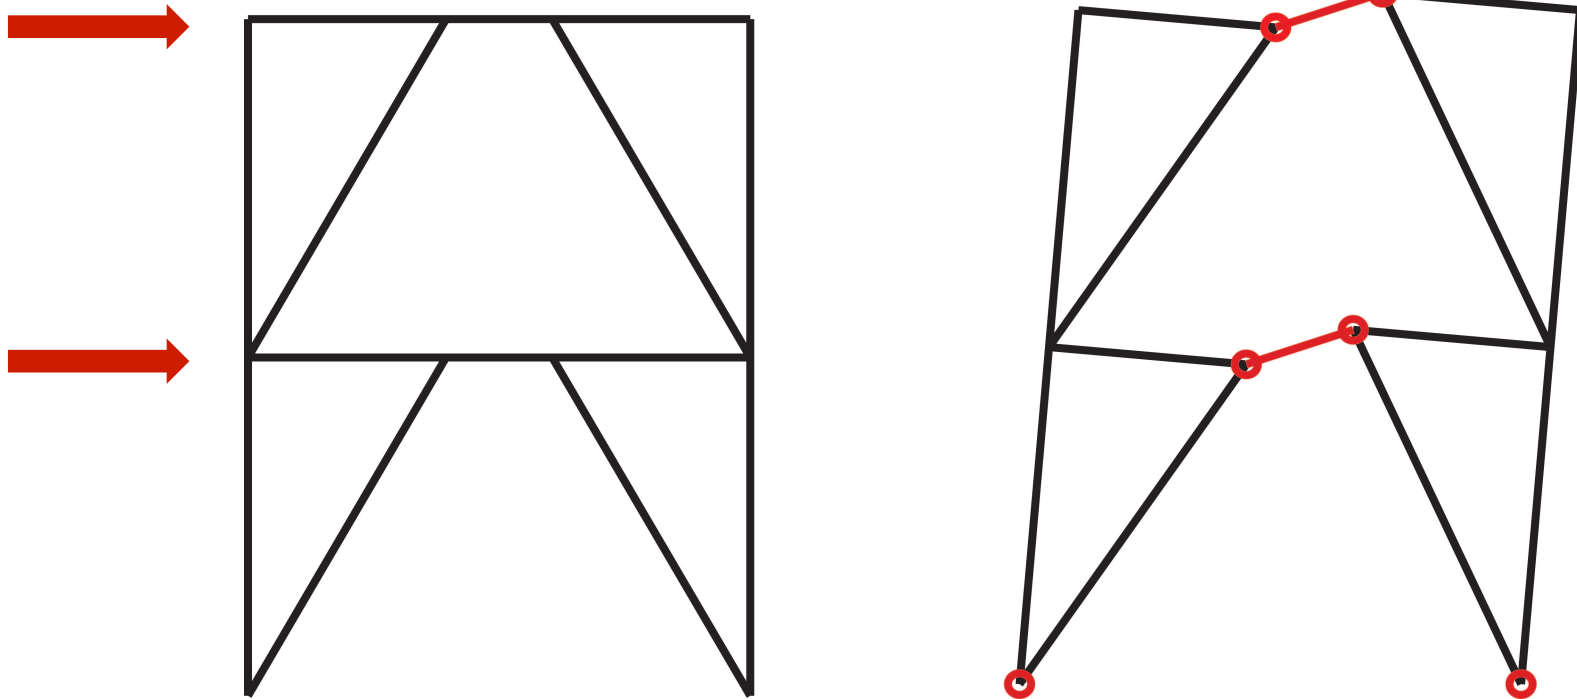
Eccentrically Braced Frames

As a frame deforms beyond its elastic range, the beams **yield in shear** in the central “link”

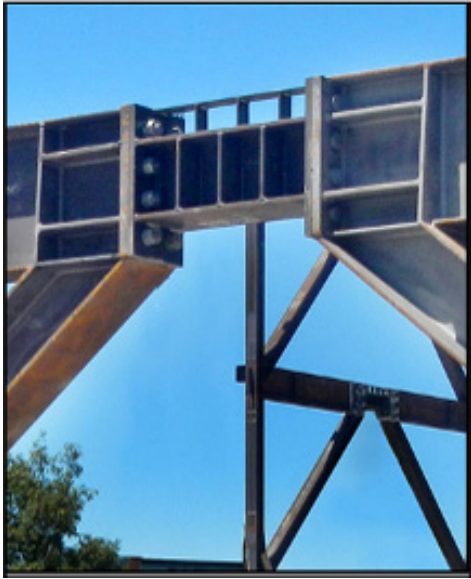
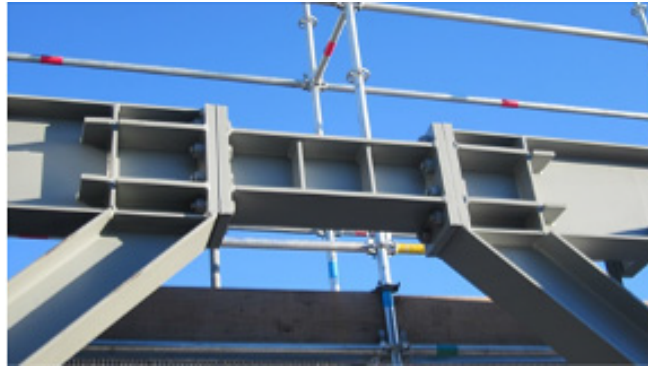
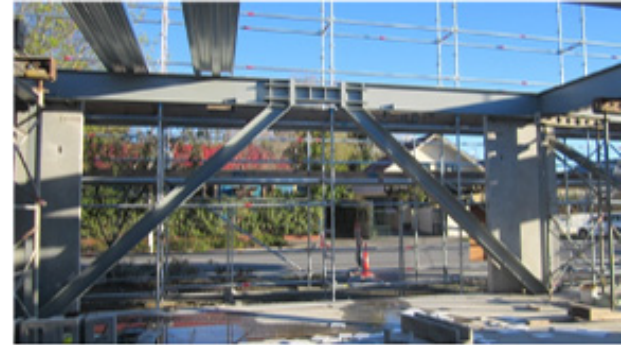
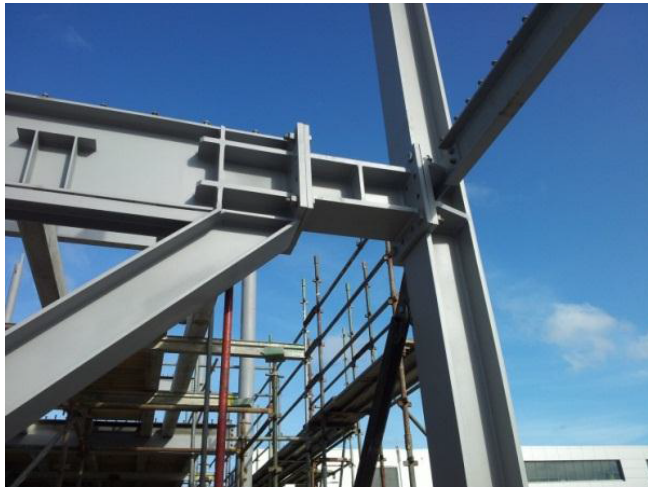
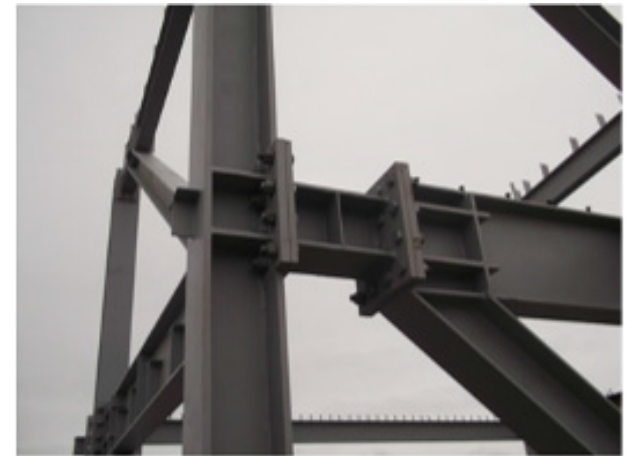
Replaceable Links in Christchurch, NZ

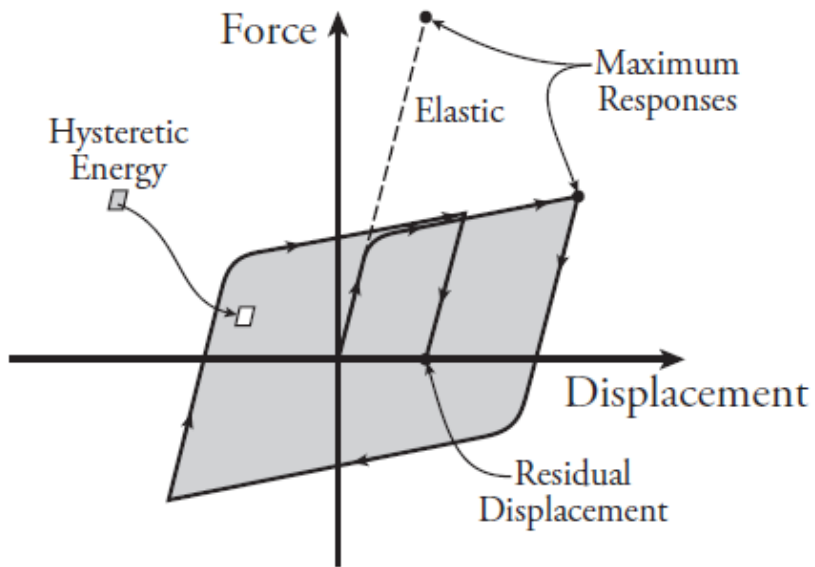
YIELDING/FRICTION SYSTEM

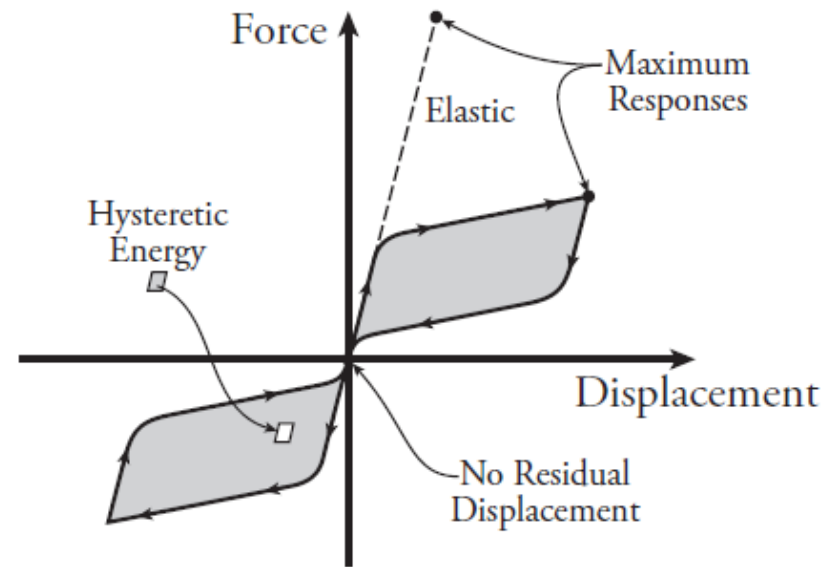
SELF-CENTERING SYSTEM

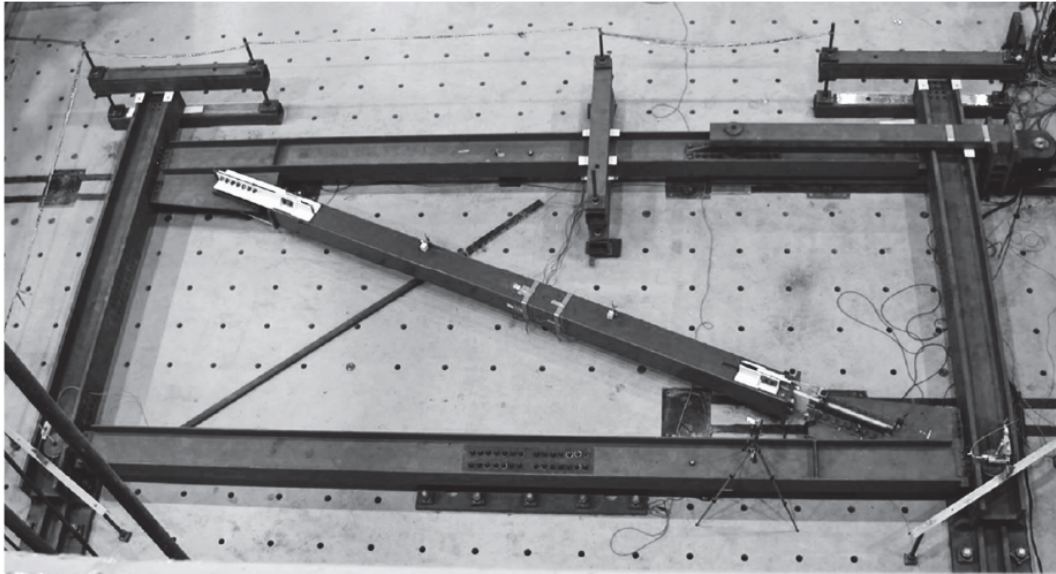
TEST SETUP PHOTO

Self-Centring Brace

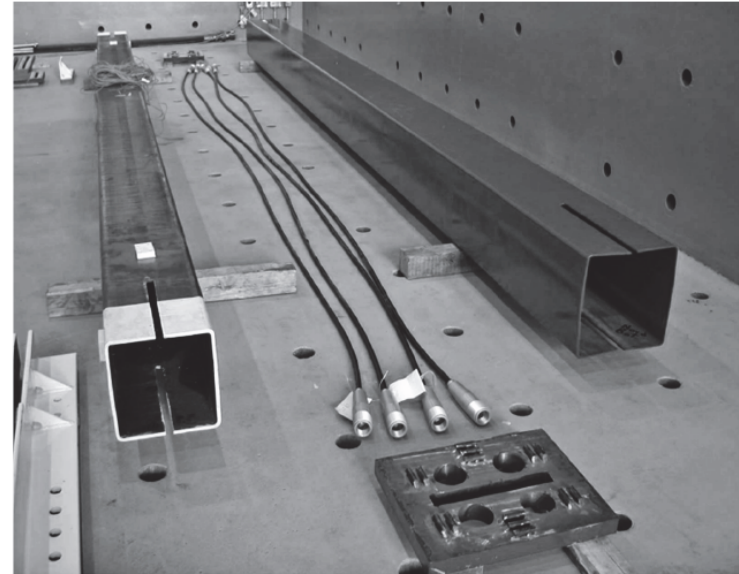
DISASSEMBLED SCED BRACE

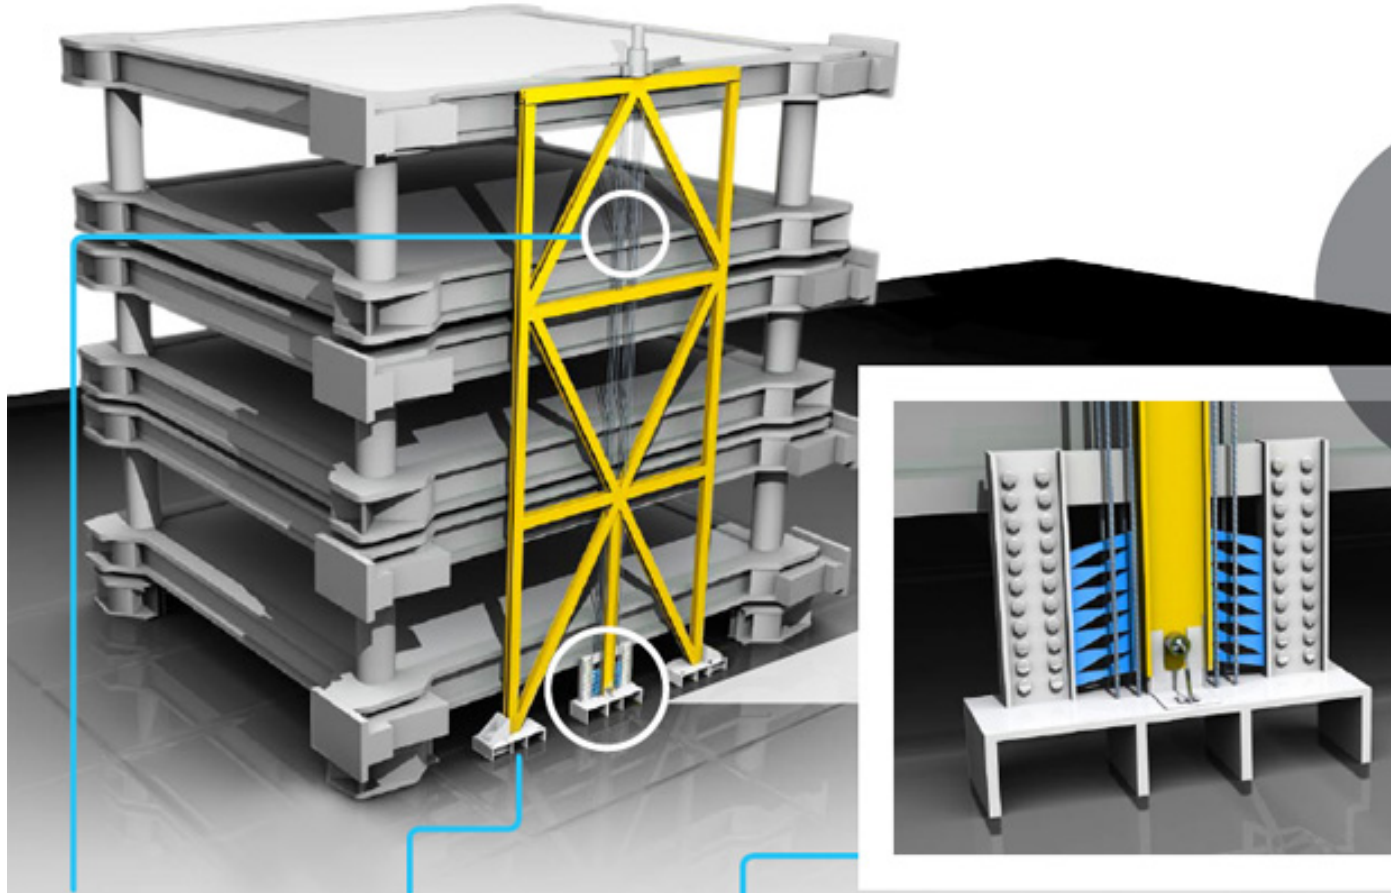
Rocking Frame

Post-tensioning
provides self-
centering

Column bases
designed to uplift

Energy dissipation
via steel plates
